DEPARTMENT OF NATURAL RESOURCES
DIVISION OF OIL, GAS AND MINING

RE: Site Inspections; UMETCO Minerals Corporation; Calliham (M/037/023), Wilson-Silver Bell (M/037/027), and Deremo-Peterson (M/037/025) Projects, San Juan County, Utah

Date of Inspection: May 1, 2002
Time of Inspection: 8:30 to about 11:30 a.m.
Conditions: Mostly clear, 40's, windy
Participants: Frank Barnett and Tony Bates, UMETCO; Doug Jensen, and Paul Baker, DOGM

M/037/023, M/037/027, and M/037/025
Calliham, Wilson-Silver Bell, and Deremo-Peterson Mines

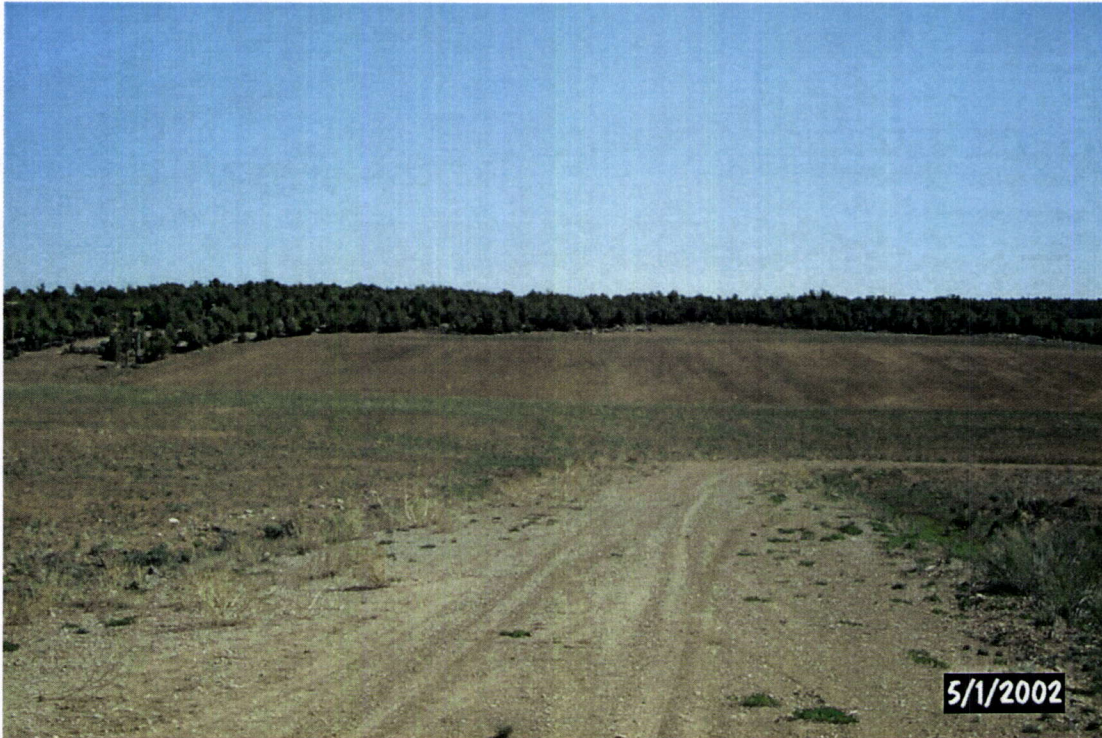
Photos 1 through 3 show the mine site. It has been graded to fairly gentle slopes that match surrounding topography quite well. The area was seeded in the fall of 2000, and the vegetation is progressing well. From a distance, it looks like there is little vegetation on the slope shown in Photo 1, but this slope actually has good vegetation cover considering there has only been one full growing season since the site was seeded. In my opinion, the vegetation on this site will continue to grow, and the operator should have little trouble meeting bond release criteria. There are some rills on one of the slopes, but they are relatively minor and should heal once vegetation is better established.

Photo 1. Calliham Mine looking toward the waste pile. There are a few rills on this pile.

I am fairly confident there will be adequate vegetation at the Calliham Mine, but we should still check it whenever possible.

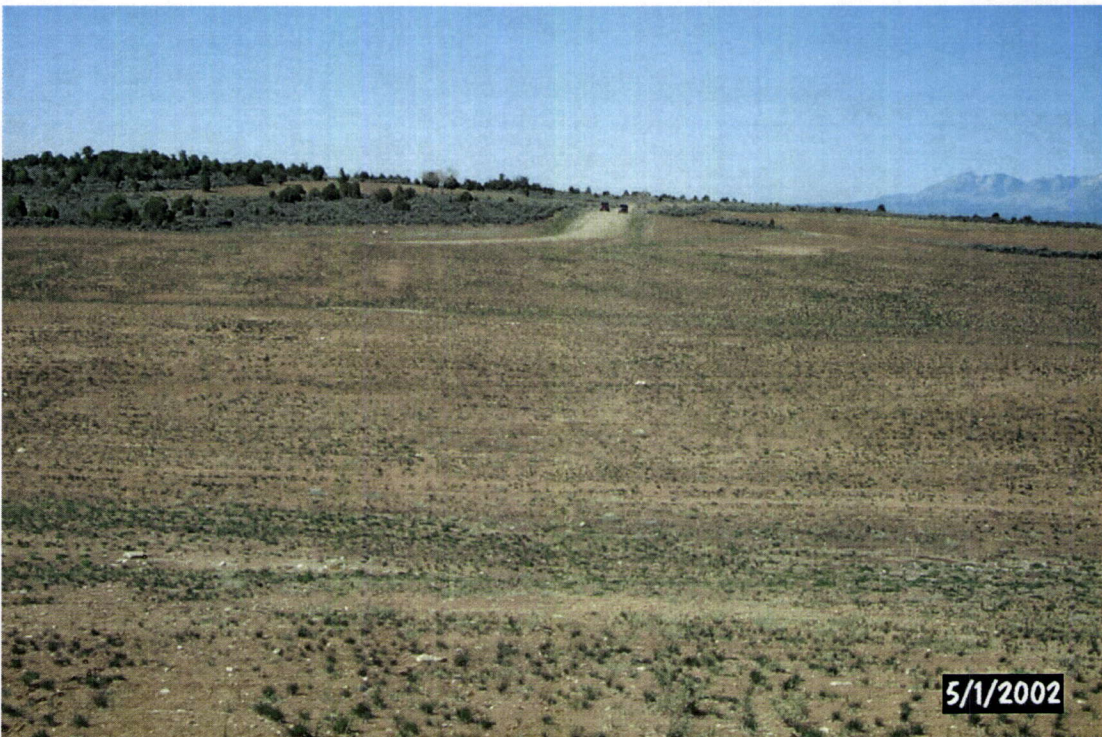
Photo 2. Calliham Mine looking from the waste pile (opposite direction as Photo 1).

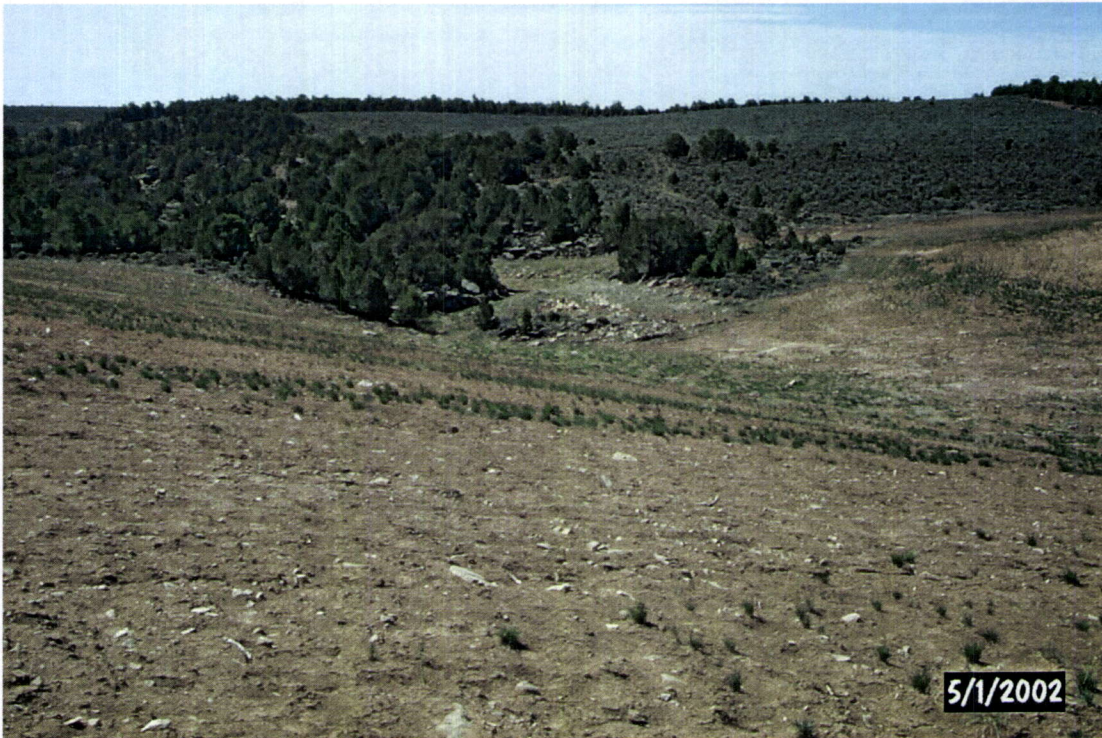
Photo 3. Calliham Mine looking toward the top of Wildhorse Canyon.

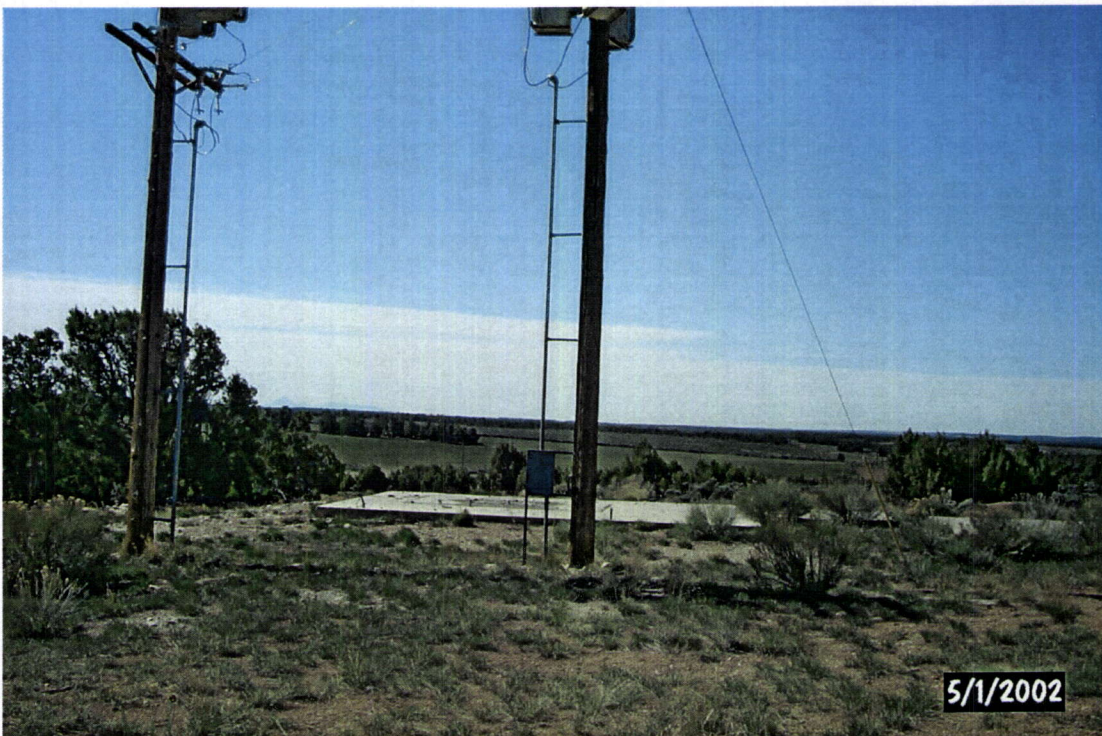
Some of the buildings and other structures, including power poles, erected for the mine have been left at the land owner's request. The power poles have Pacificorp labels, but according to Mr. Bates and Mr. Barnett, Utah Power and Light does not claim them and is not willing to replace them. Several of the poles leading into the mines have broken, and because they are not functional for the postmining land use, they need to be removed. There are some other poles with transformers near some of the vent shafts, and these appear to still be usable. The land owner has also requested that these be left. One of these vent shafts is shown in Photo 4.

Photo 4. Vent shaft near the Silver Bell Mine. The concrete pad is a compressor platform.

At the Wilson-Silver Bell Mines, the operator needs to remove the power poles leading to the mines. We will want to monitor vegetation, especially on the waste disposal area at the Wilson Mine, although I believe the vegetation will ultimately succeed.

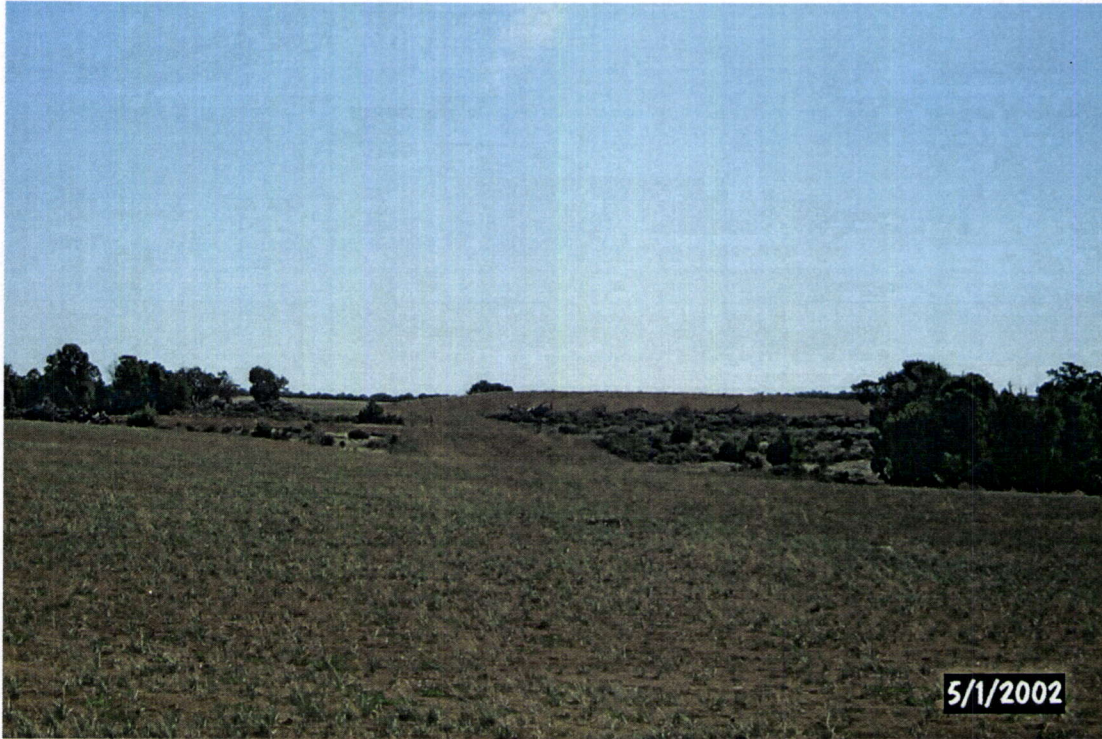
Vegetation on the waste disposal area at the Silver Bell Mine appears to be doing very well. I am a little more concerned about vegetation at the Wilson Mine. Although it is more sparse and consists of more sweet clover than I would like to see, I believe it will probably progress and that reseedling will not be necessary. Photos 5 and 6 show the Silver Bell Mine waste disposal area.

Photo 5. Silver Bell Mine waste disposal area with Wilson Mine in the background.

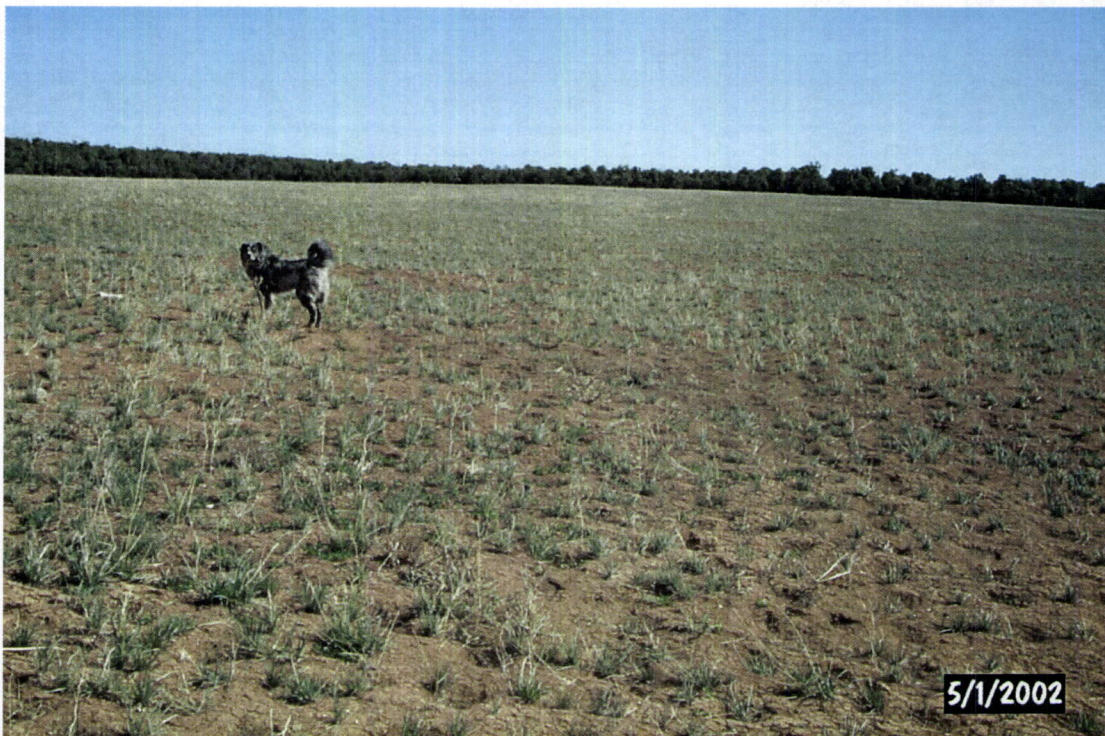
In Photo 6, one can see the small depressions that were made when the site was seeded. This was done with the idea that the depressions would increase water retention and vegetation establishment and growth. We could not tell that there was greater establishment in the depressions compared to outside the depressions; however, I suspect that they increase the amount of moisture held on the slopes and improve growth. Larger depressions, such as those the operator used at the Sunset Mine, may be more beneficial.

Photo 6. Silver Bell Mine. Note the small depressions in the soil.

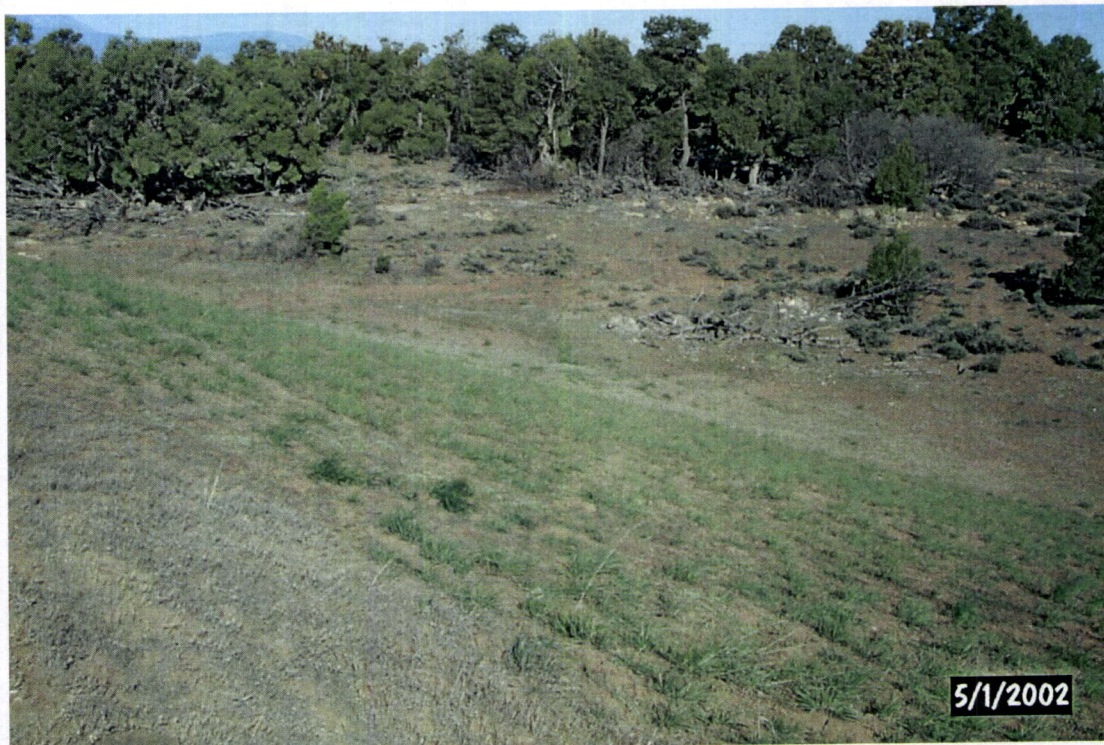
The Deremo-Peterson Mine was seeded with grasses at the land owner's request. Seeding was done in 1999. The north side of the waste pile is well vegetated, but other portions of the pile have scattered vegetated areas (Photos 7, 8, and 9). There was an ore pad north of the waste disposal

Photo 7. Deremo-Peterson Mine, north side of waste disposal area. Note the amount of perennial vegetation compared to photos below.

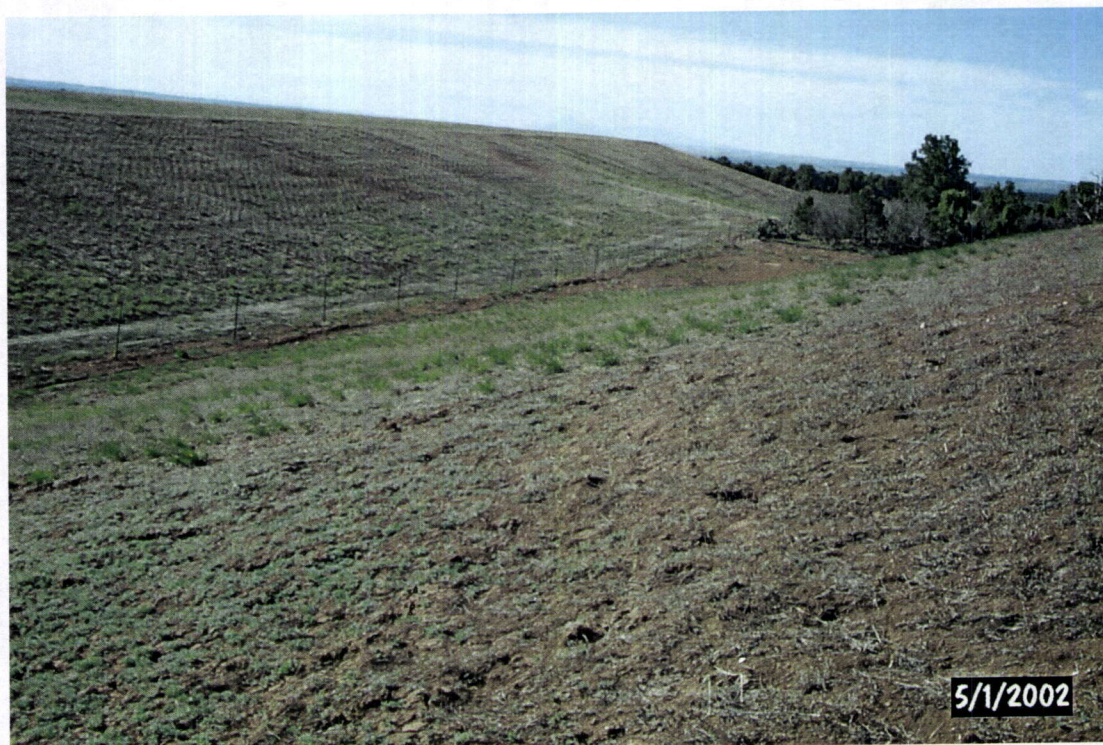
Vegetation establishment and growth at the Deremo-Peterson site has almost certainly been adversely affected by lack of rainfall, but considering how well the two nearby sites have done, this cannot be the only reason for the lack of vegetation in this area. The site does not meet the revegetation criteria for release.

Photo 8. East side of Deremo Peterson waste disposal area. Note the relatively small amount of perennial grass cover compared to the north side of this pile. The fence is at the Colorado state line, so the pile in the background is in Colorado.

I suggest that the operator wait until fall then reseed those areas where there is minimal perennial vegetation. Because of the number of weeds that have become established, I have some concerns about reseeding, but I believe there is not enough perennial vegetation for it to spread and meet bond release criteria without supplemental seeding.

Redisturbing an area like this tends to further increase weed growth, so I suggest that the operator either not use fertilizer or minimize the amount of fertilizer used. I do not recommend that the operator use herbicides for weed control, but that would be an acceptable option. To decrease the number of weed seeds that could germinate next year, the operator might use a broadleaf herbicide on the weeds this summer before they are able to set seed. Another choice would be to wait until next spring after the reseeded grasses have germinated and established then use an herbicide specific to broadleaf weeds. Although I have seen these methods used, the results have been mixed. I am not sure how much the herbicide applications improved grass establishment.

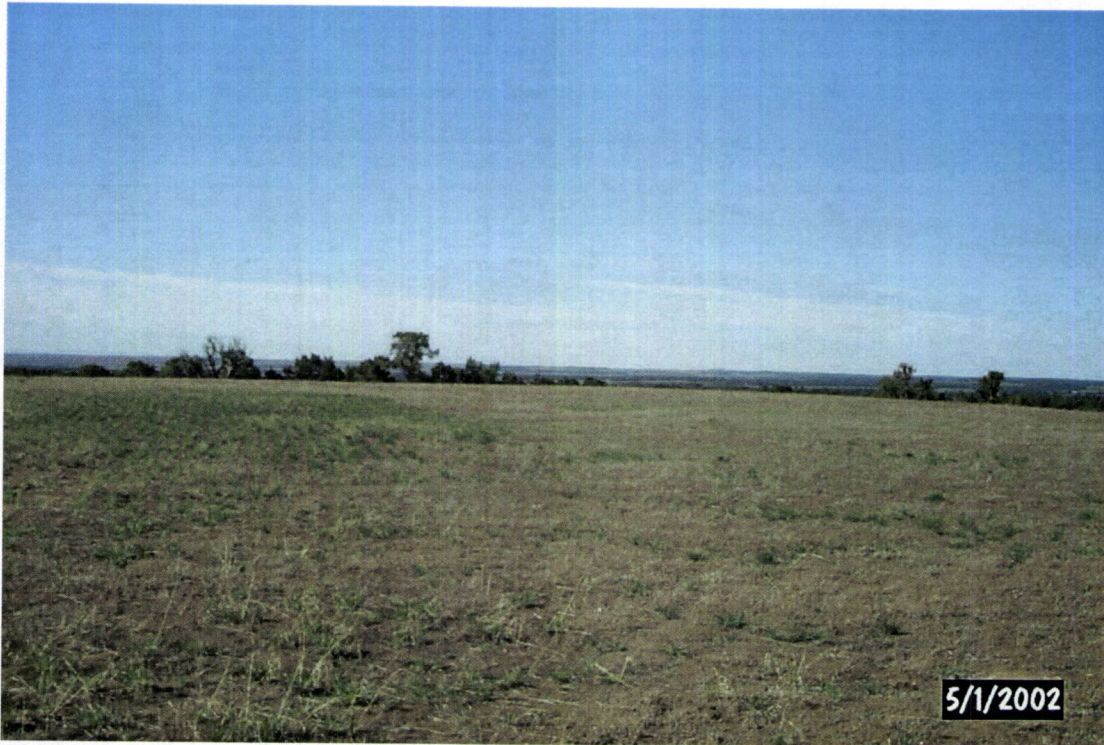
Photo 9. Top of the Deremo-Peterson waste pile.

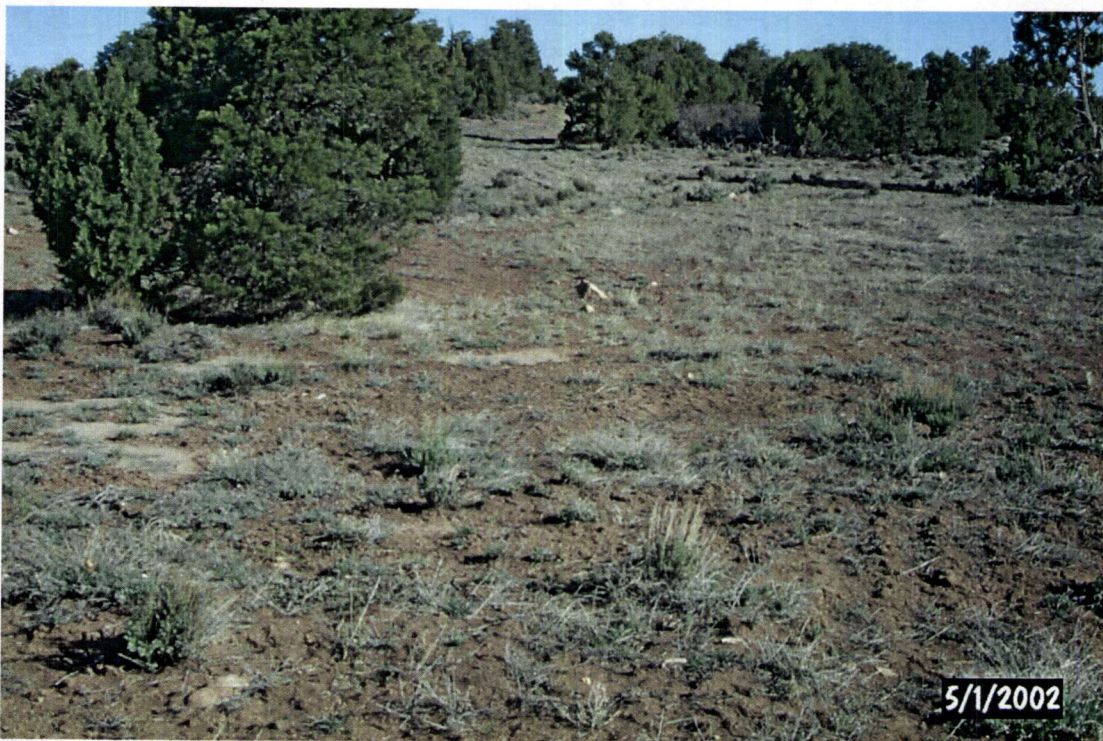
area, and it has little or no desirable vegetation. We were told that this area was essentially bedrock with just a couple of inches of soil placed on it. I also took a photo of a nearby undisturbed area for comparison (Photo 10). The undisturbed area also had little soil, but it may be unfair to compare a near-climax community to a site reclaimed three years ago.

Photo 10. Undisturbed area near Deremo-Peterson Mine.
